ADDENDUM NO. 2

**UCPATH ROOFING PROJECT
PROJECT NO. 950566
CONTRACT NO. 950566-LF-2022-76**

FIELD REPORT

Project: UC – Path Building
14350 Meridian Parkway
Riverside, CA 92518

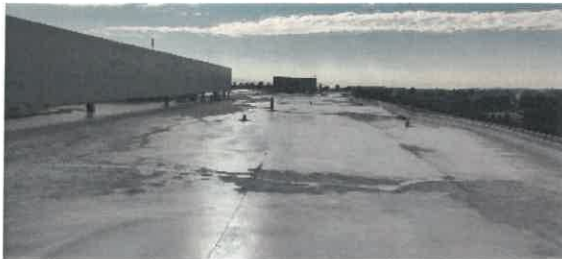
Photo #1 Overview of the south section of the building.

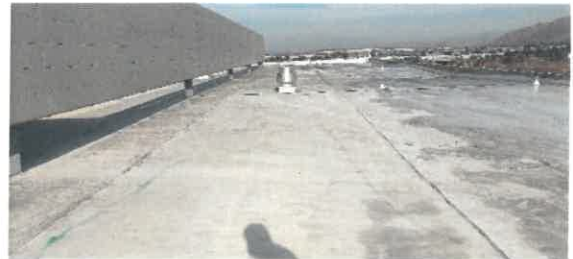
Photo #2 Overview of the north section of the building.

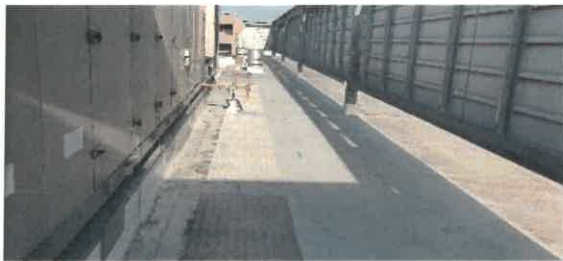
Photo #3 Overview of the center section of one of the roof sections inside the equipment screen wall.

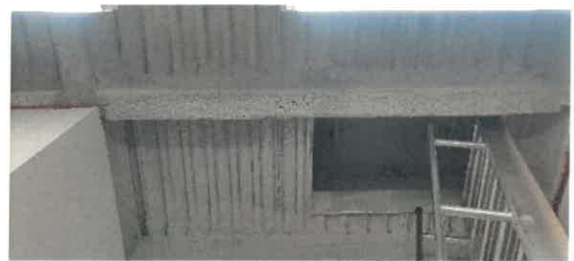
Photo #4 Underside of the roof decking.

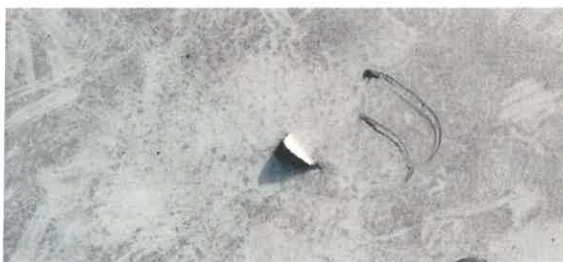
Specimen Age: Existing system. The roof is original to construction in 2008. The system appears to be in poor condition with multiple holes in the membrane observed.

Photo #5 Typical damage to the roof membrane.

Our recommendation is that the roof system be replaced.

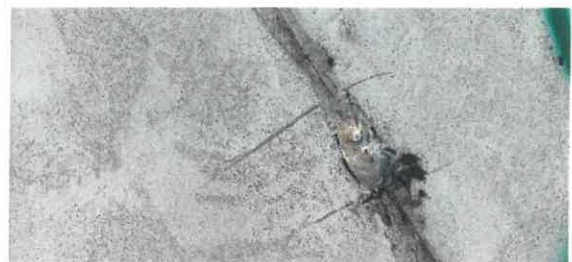
Photo #6 Typical damage to the roof membrane.

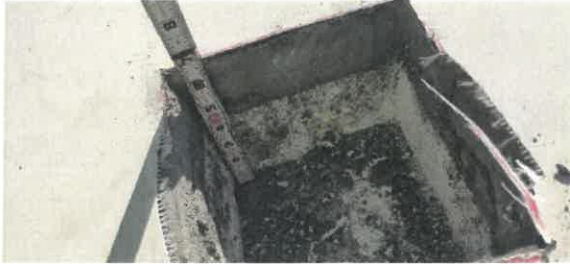
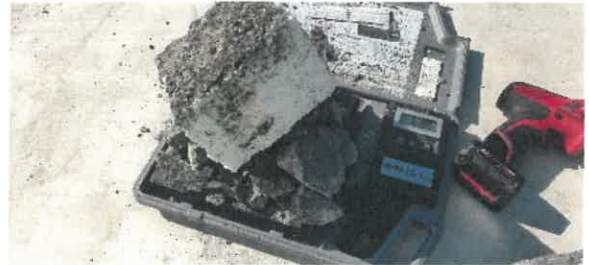
Photo #7 General overview of the make-up of core 'A'.

Photo #8 Close-up view of core 'A'.

6.5"x6.25" Core Profile:		CORE THICKNESS	6 1/2	IN
	Layer	Type	Thickness	
	Roof Membrane	Thermoplastic	- - -	
	Insulation - Layer 1	Lightweight Concrete	2 1/2	in
	Insulation - Layer 2	EPS	4	in
	Decking	Metal		
				1/4-inch slope to the drain.
				Core wet to the touch.
CORE (B)		CORE WT.	2.01	LB
		CORE SIZE	0.27	SF
		CORE UNIT WT.	7.44	PSF

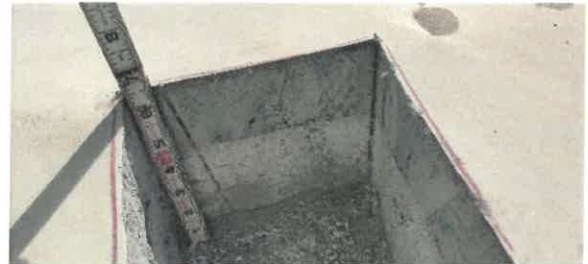
Photo #9 General overview of the make-up of core 'B'.

Photo #10 Close-up view of core 'B'.

6.25"x6.25" Core Profile:		CORE THICKNESS	6 1/2	IN
	Layer	Type	Thickness	
	Roof Membrane	Thermoplastic	- - -	
	Insulation - Layer 1	Lightweight Concrete	2 1/2	in
	Insulation - Layer 2	EPS	4	in
	Decking	Metal		
				1/4-inch slope to the drain.
				Core was dry to the touch.
CORE (C)		CORE WT.	3.57	LB
		CORE SIZE	0.26	SF
		CORE UNIT WT.	13.73	PSF

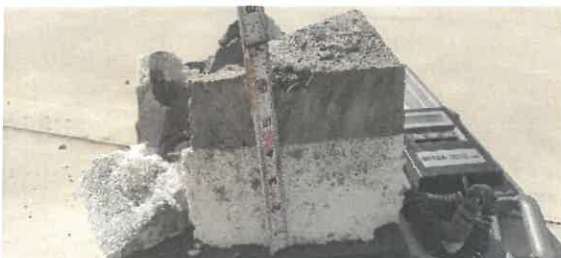
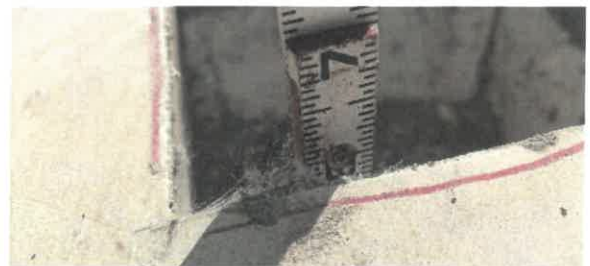
Photo #11 General overview of the make-up of core 'C'.

Photo #12 Close-up view of core 'C'.

6.25"x6" Core Profile:		CORE THICKNESS	6 1/2	IN
	Layer	Type	Thickness	
	Roof Membrane	Thermoplastic	- - -	
	Insulation - Layer 1	Lightweight Concrete	2 1/2	in
	Insulation - Layer 2	EPS	4	in
	Decking	Metal		
				1/4-inch slope to the drain.
				Core wet to the touch.
CORE (D)		CORE WT.	3.36	LB
		CORE SIZE	0.29	SF
		CORE UNIT WT.	11.59	PSF

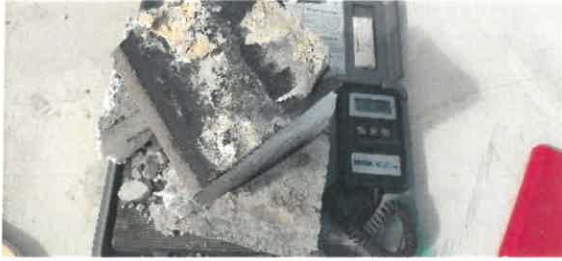
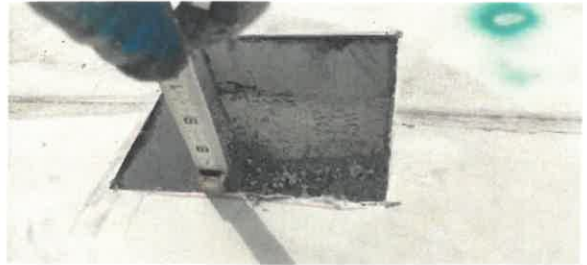
Photo #13 General overview of the make-up of core 'D'.

Photo #14 Close-up view of core 'D'.

6.25"x6.5" Core Profile:		CORE THICKNESS	6 1/2	IN
	Layer	Type	Thickness	
	Roof Membrane	Thermoplastic	- - -	
	Insulation - Layer 1	Lightweight Concrete	2 1/2	in
	Insulation - Layer 2	EPS	4	in
	Decking	Metal		
				1/4-inch slope to the drain.
				Core wet to the touch.

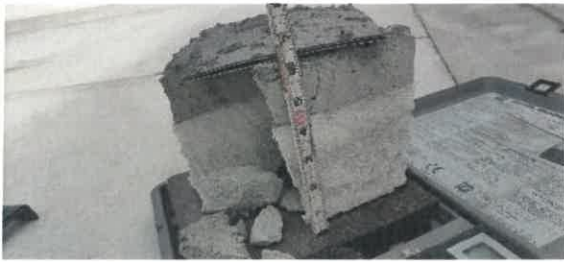
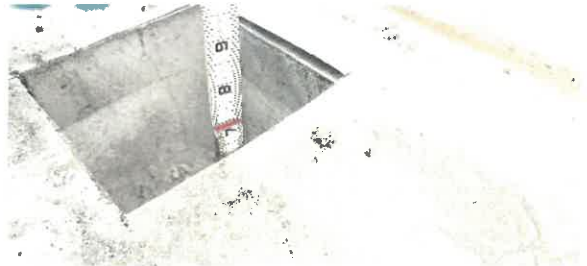
Photo #15 General overview of the make-up of core 'E'.

Photo #16 Close-up view of core 'E'.

Roof Core Information		ASSESSMENT COMPANY:		Terracon Consultants, Inc.	
			FIELD ASSESSOR:	Andrew C. Dimond, RRO	
			PROJECT LOCATION:	Riverside, CA	
CORE (E)		CORE WT.	2.02	LB	COMMENTS
		CORE SIZE	0.27	SF	Core taken at the parapet wall
		CORE UNIT WT.	7.48	PSF	condition.

6.5"x6" Core Profile:		CORE THICKNESS	6 1/2	IN	All layers dry to the touch.
	Layer	Type	Thickness		1/2-inch slope to the drain.
	Roof Membrane	Thermoplastic	---		
	Insulation - Layer 1	Lightweight Concrete	2 1/2	in	
	Insulation - Layer 2	EPS	4	in	
	Decking	Metal			
CORE (F)		CORE WT.	2.99	LB	COMMENTS
		CORE SIZE	0.28	SF	Core taken at the roof expansion
		CORE UNIT WT.	10.68	PSF	joint.

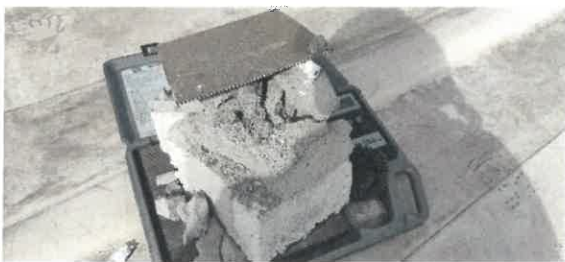
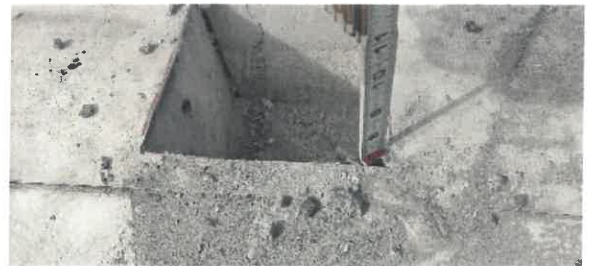
Photo #17 General overview of the make-up of core 'F'.

Photo #18 Close-up view of core 'F'.

6.5"x6.25" Core Profile:		CORE THICKNESS	7	IN	All layers of the core were dry to
	Layer	Type	Thickness		the touch.
	Roof Membrane	Thermoplastic	---		1/2-inch slope perpendicular to the
	Insulation - Layer 1	Lightweight Concrete	3	in	expansion joint.
	Insulation - Layer 2	EPS	4	in	
	Decking	Metal			
CORE (G)		CORE WT.	1.99	LB	COMMENTS
		CORE SIZE	0.27	SF	All layers dry to the touch.
		CORE UNIT WT.	7.37	PSF	1/4-inch slope to the drain.

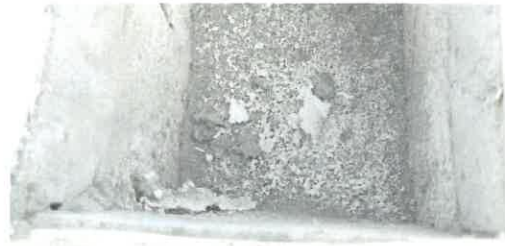
Photo #19 General overview of the make-up of core 'G'.

Photo #20 Close-up view of core 'G'.

6.5"x6" Core Profile:		CORE THICKNESS	6	IN	
	Layer	Type	Thickness		
	Roof Membrane	Thermoplastic	---		
	Insulation - Layer 1	Lightweight Concrete	2	in	
	Insulation - Layer 2	EPS	4	in	
	Decking	Metal			
CORE (H)		CORE WT.	3.63	LB	COMMENTS
		CORE SIZE	0.27	SF	All layers dry to the touch.
		CORE UNIT WT.	13.44	PSF	1/4-inch slope to the drain.

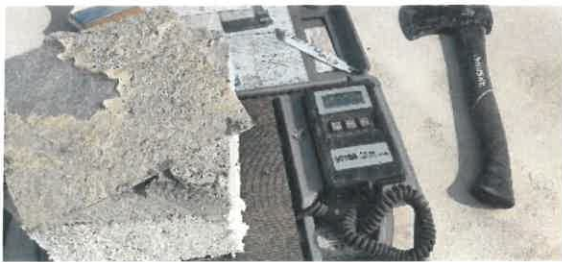
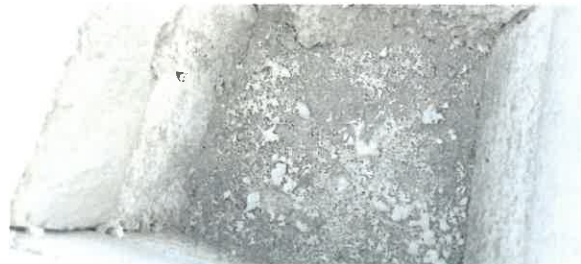
Photo #21 General overview of the make-up of core 'H'.

Photo #22 Close-up view of core 'H'.

6.25"x6.25" Core Profile:		CORE THICKNESS	6	IN	
	Layer	Type	Thickness		
	Roof Membrane	Thermoplastic	---		
	Insulation - Layer 1	Lightweight Concrete	2	in	
	Insulation - Layer 2	EPS	4	in	
	Decking	Metal

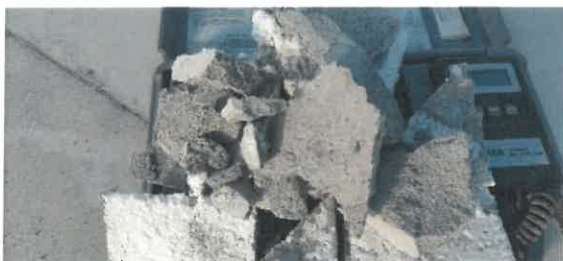
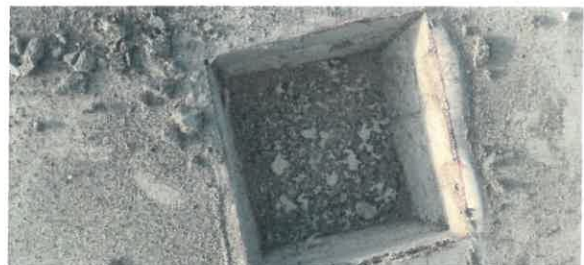
Photo #23 General overview of the make-up of core 'I'.

Photo #24 Close-up view of core 'I'.

Roof Core Information		ASSESSMENT COMPANY:		Terracon Consultants, Inc.	
			FIELD ASSESSOR:	Andrew C. Dimond, RRO	
			PROJECT LOCATION:	Riverside, CA	
CORE (I)		CORE WT.	2.08	LB	COMMENTS
		CORE SIZE	0.26	SF	All layers dry to the touch.
		CORE UNIT WT.	8.00	PSF	1/4-inch slope to the drain.
6"x6.25" Core Profile:		CORE THICKNESS	6	IN	
	Layer	Type	Thickness		
	Roof Membrane	Thermoplastic	---		
	Insulation - Layer 1	Lightweight Concrete	2	in	
	Insulation - Layer 2	EPS	4	in	
	Decking	Metal			
CORE (J)		CORE WT.	2.48	LB	COMMENTS
		CORE SIZE	0.27	SF	Membrane not adhered.
		CORE UNIT WT.	9.19	PSF	Core wet to the touch.
6"x6.5" Core Profile:		CORE THICKNESS	6	IN	1/4-inch slope to the drain.
	Layer	Type	Thickness		
	Roof Membrane	Thermoplastic	---		
	Insulation - Layer 1	Lightweight Concrete	2	in	
	Insulation - Layer 2	EPS	4	in	
	Decking	Metal			
CORE (K)		CORE WT.	2.54	LB	COMMENTS
		CORE SIZE	0.27	SF	Core taken inside the equipment

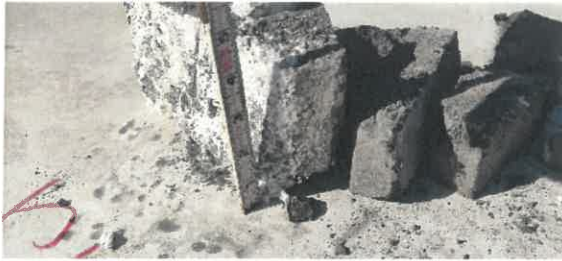
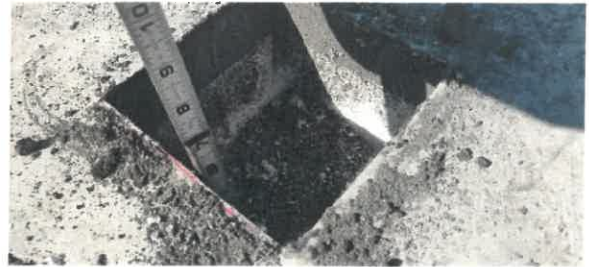
Photo #25 General overview of the make-up of core 'J'.

Photo #26 Close-up view of core 'J'.

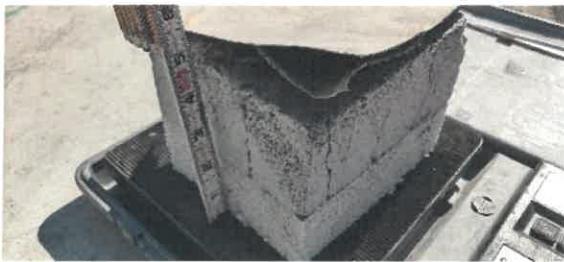
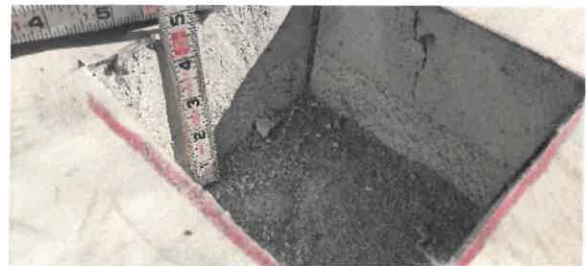
Photo #27 General overview of the make-up of core 'K'.

Photo #28 Close-up view of core 'K'.

CORE UNIT WT.	9.41	PSF	screen wall area.
6"x6.5" Core Profile:		CORE THICKNESS	4 1/2	IN	Decking is concrete not metal at this
	Layer	Type	Thickness		location.
	Roof Membrane	Thermoplastic	---		All layers dry to the touch.
	Insulation - Layer 1	Lightweight Concrete	2 1/2	in	1/4-inch slope to the drain.
	Insulation - Layer 2	EPS	2	in	
	Decking	Structural Concrete			
CORE (L)		CORE WT.	2.64	LB	COMMENTS
		CORE SIZE	0.28	SF	Core taken at location of a bad
		CORE UNIT WT.	9.43	PSF	patch.

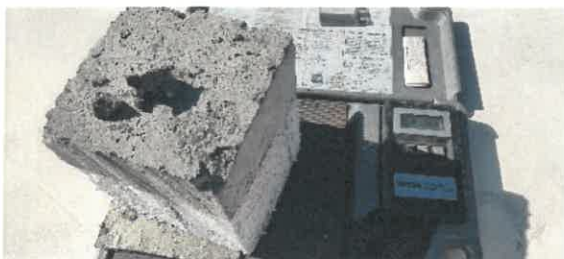
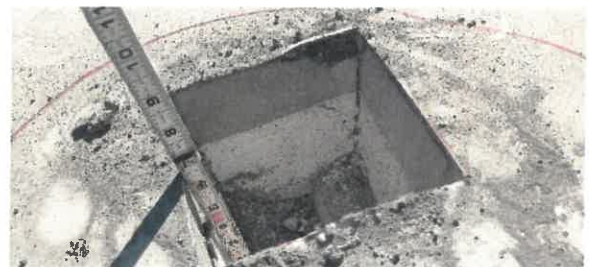
Photo #29 General overview of the make-up of core 'L'.

Photo #30 Close-up view of core 'L'.

6.25"x6.5" Core Profile:		CORE THICKNESS	6	IN	All layers dry to the touch.
	Layer	Type	Thickness		1/4-inch slope to the drain.
	Roof Membrane	Thermoplastic	---		
	Insulation - Layer 1	Lightweight Concrete	2	in	
	Insulation - Layer 2	EPS	4	in	
	Decking	Metal
